# South Oahu Shoreline Change: Diamond Head – Pearl Harbor

Chip Fletcher and Brad Romine  
University of Hawaii  
Coastal Geology Group

# South Oahu Shoreline Change

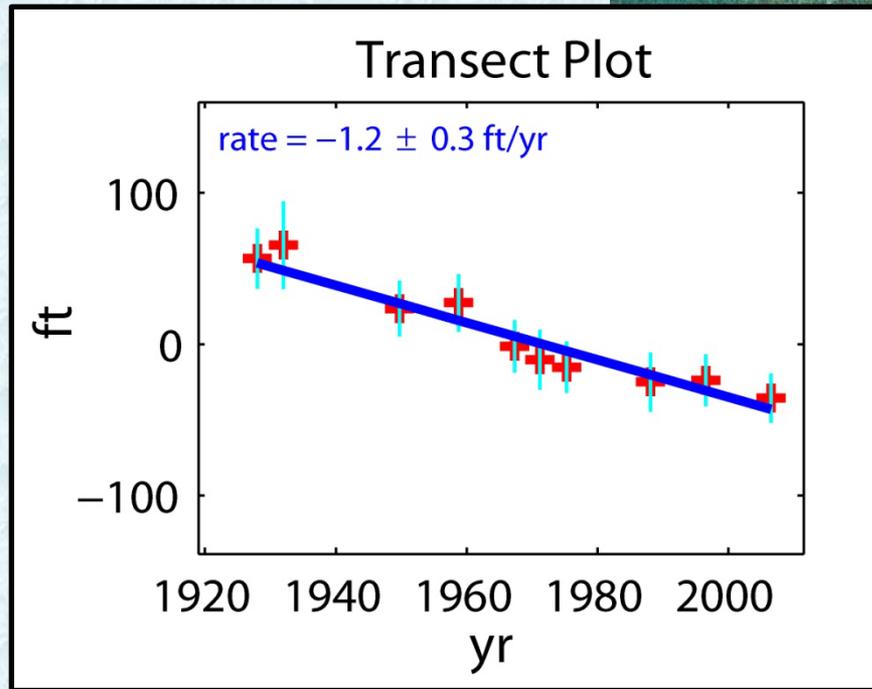
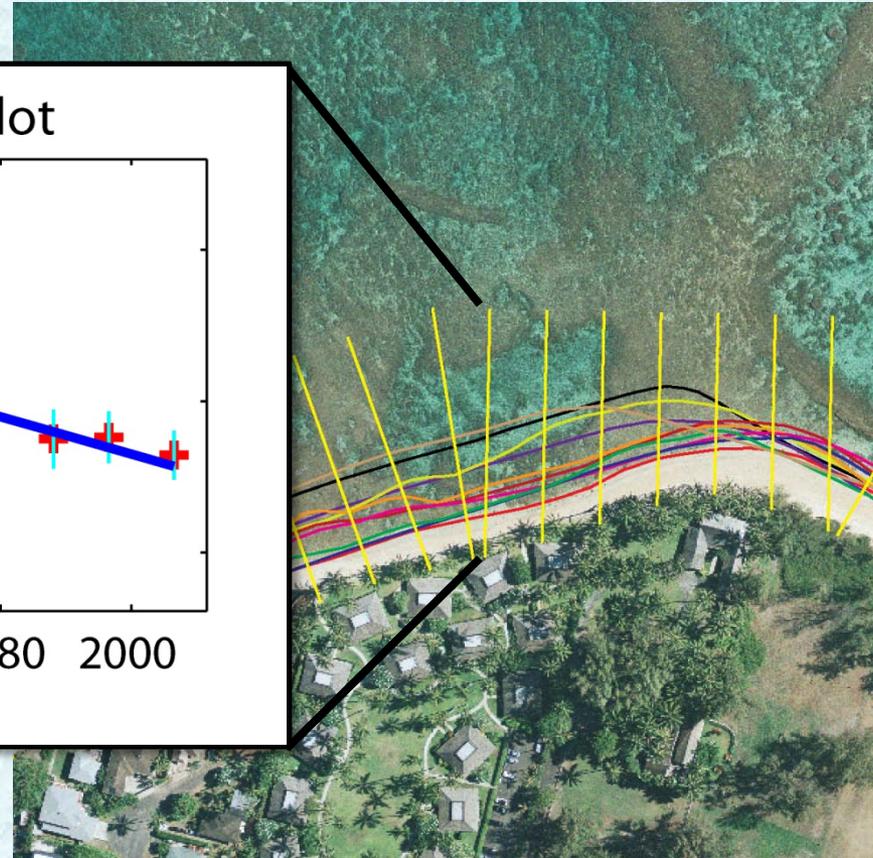
# Mapping Historical Shorelines

portion of an aerial photo mosaic

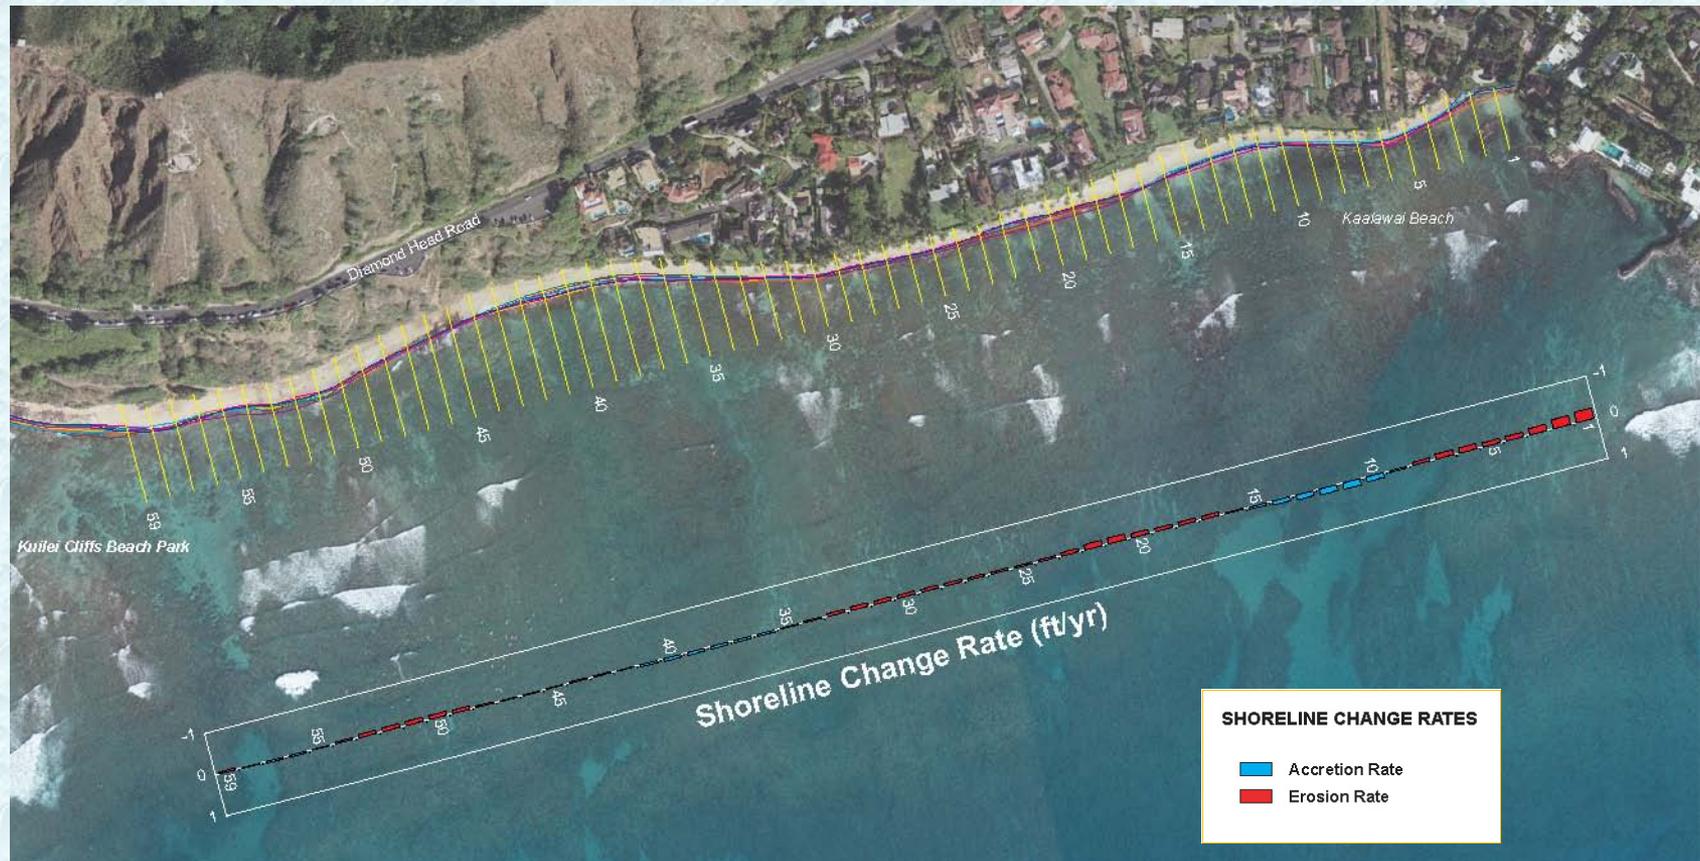
# Diamond Head: Black Pt-Cliffs

- Mostly stable 1927-2005 (rates  $<0.2$  ft/yr)

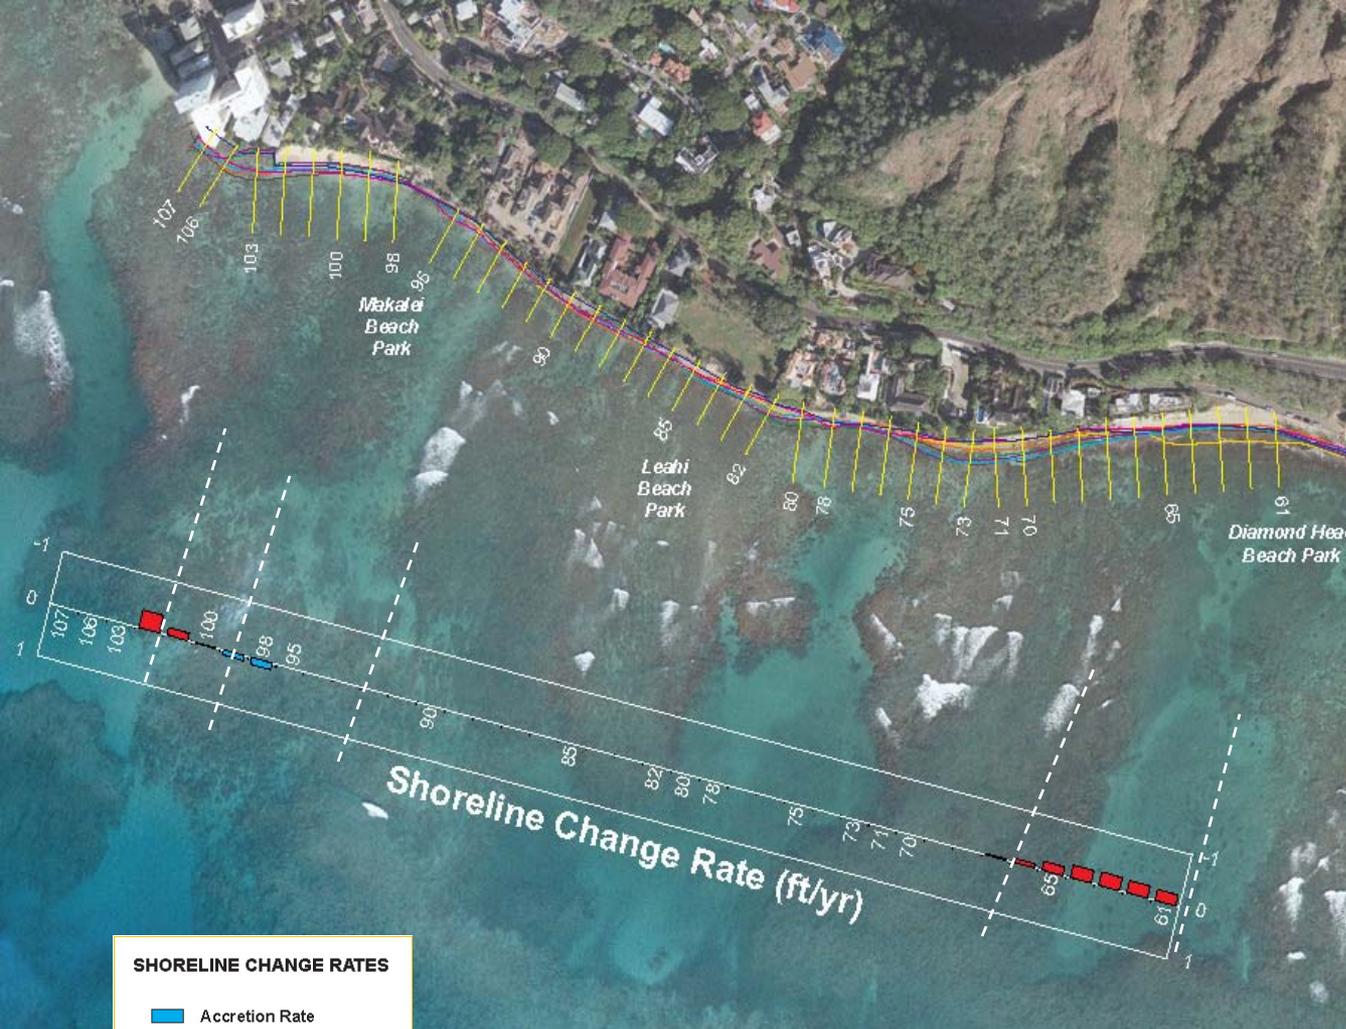
# Diamond Head, Leahi, Makalei BP's

- Beach largely lost to erosion in the past few decades
- Waves break against seawalls fronting homes
- Beach remaining only at Makalei and D.H. Beach Parks: stable to slightly erosional

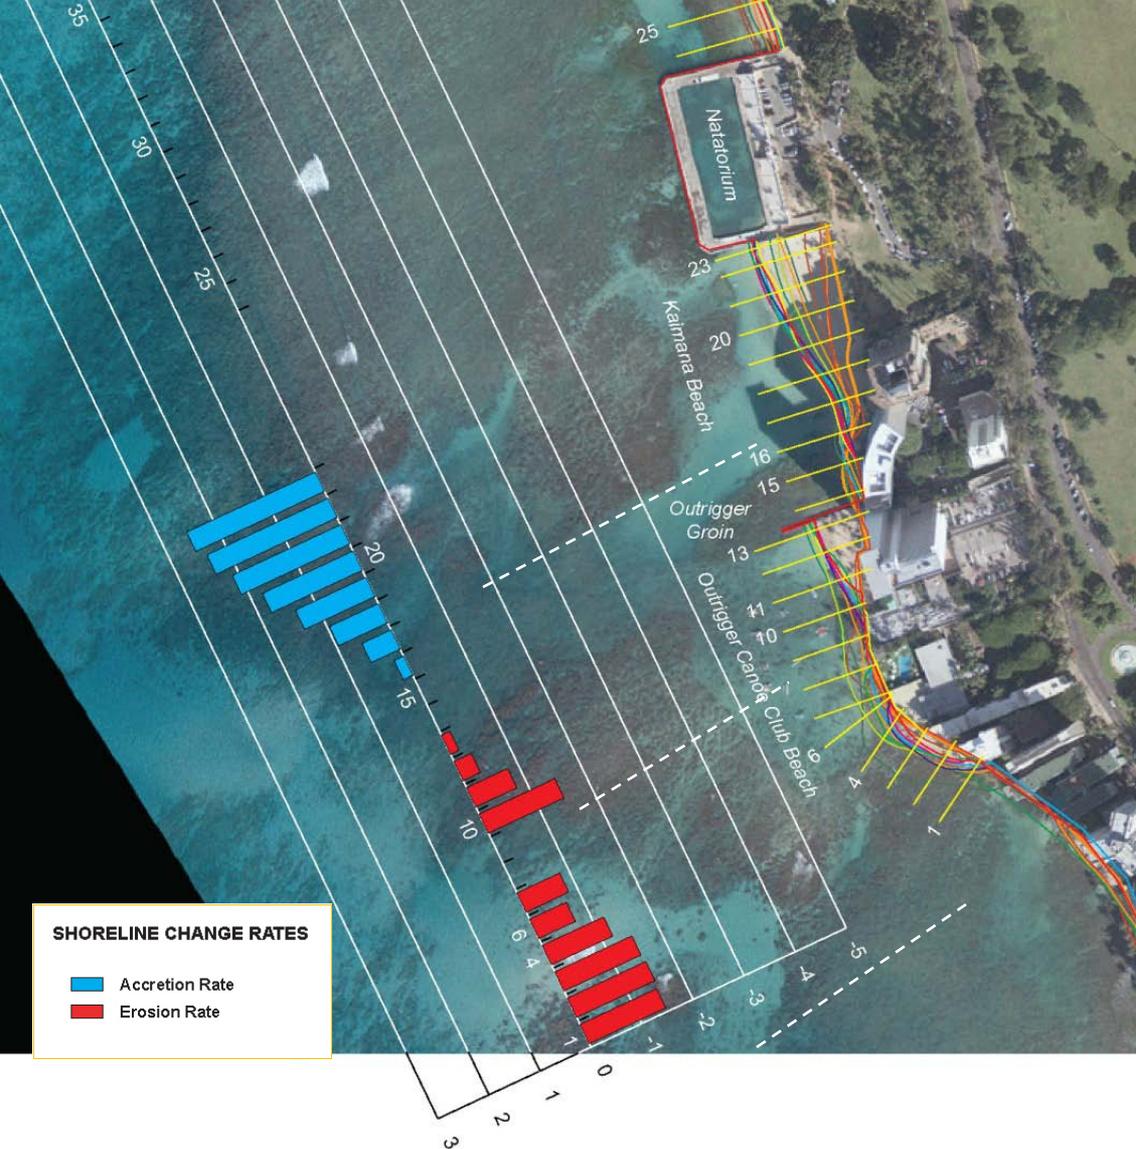
# Outrigger to Kaimana Beach

## Outrigger – Elks (1968-2005)

- 1960's: Beach and filled groin
- Erosion  $\sim 1$  ft/yr
- Beach lost near center

## Kaimana Beach (1927-2005)

- 1927: Natatorium
- Sand transport to the north
- Accretion  $>2$  ft/yr against Natatorium wall
- Beach lost at south end
- Beach occasionally graded, last grading Feb., 2002

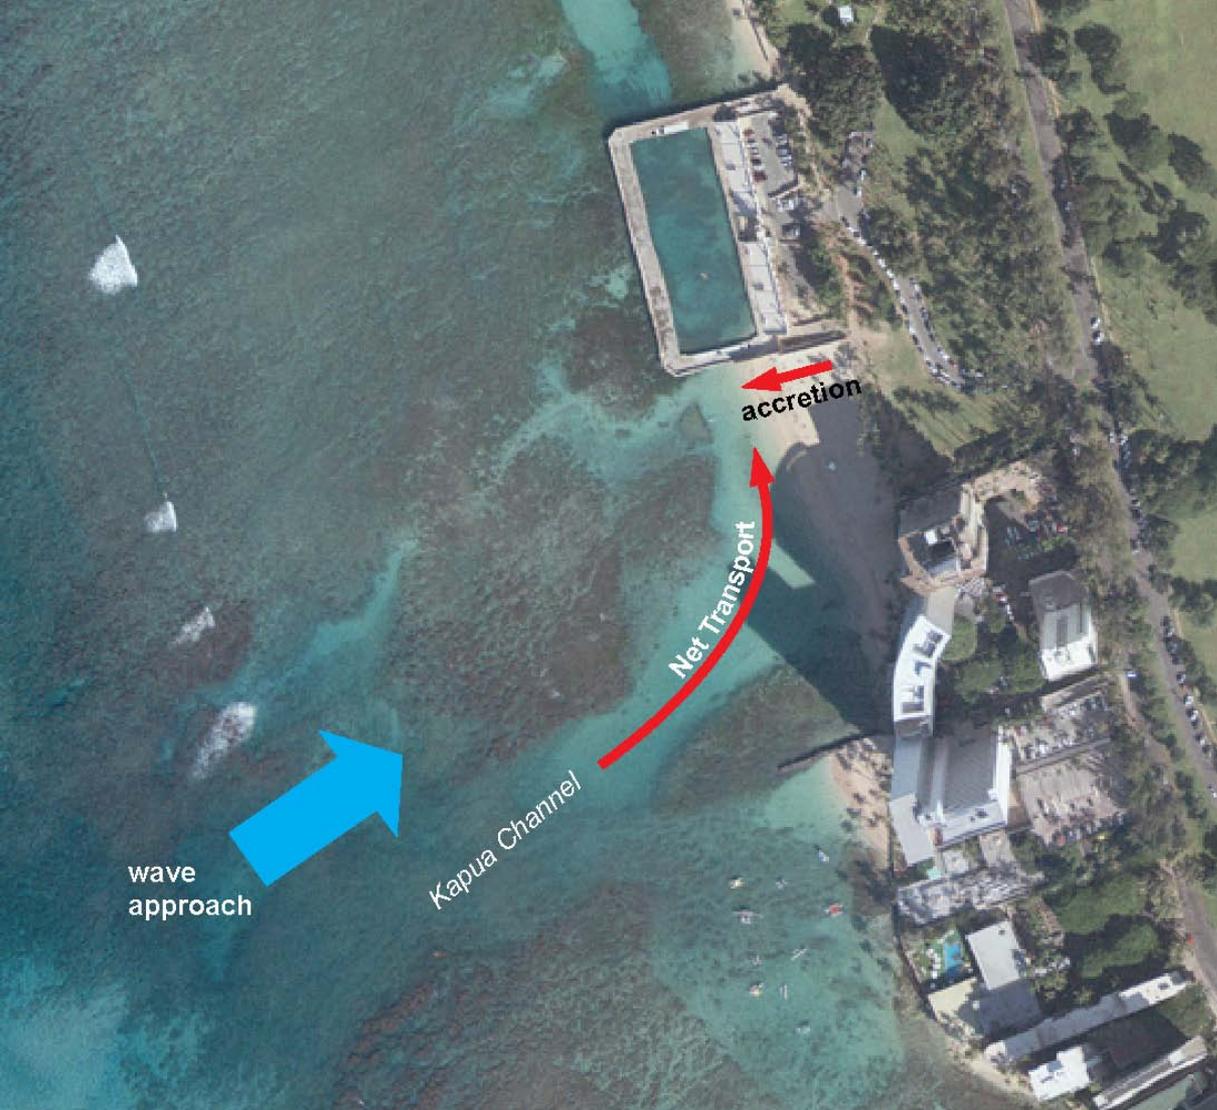
# Kaimana Beach

Adapted from Miller and Fletcher, 2003

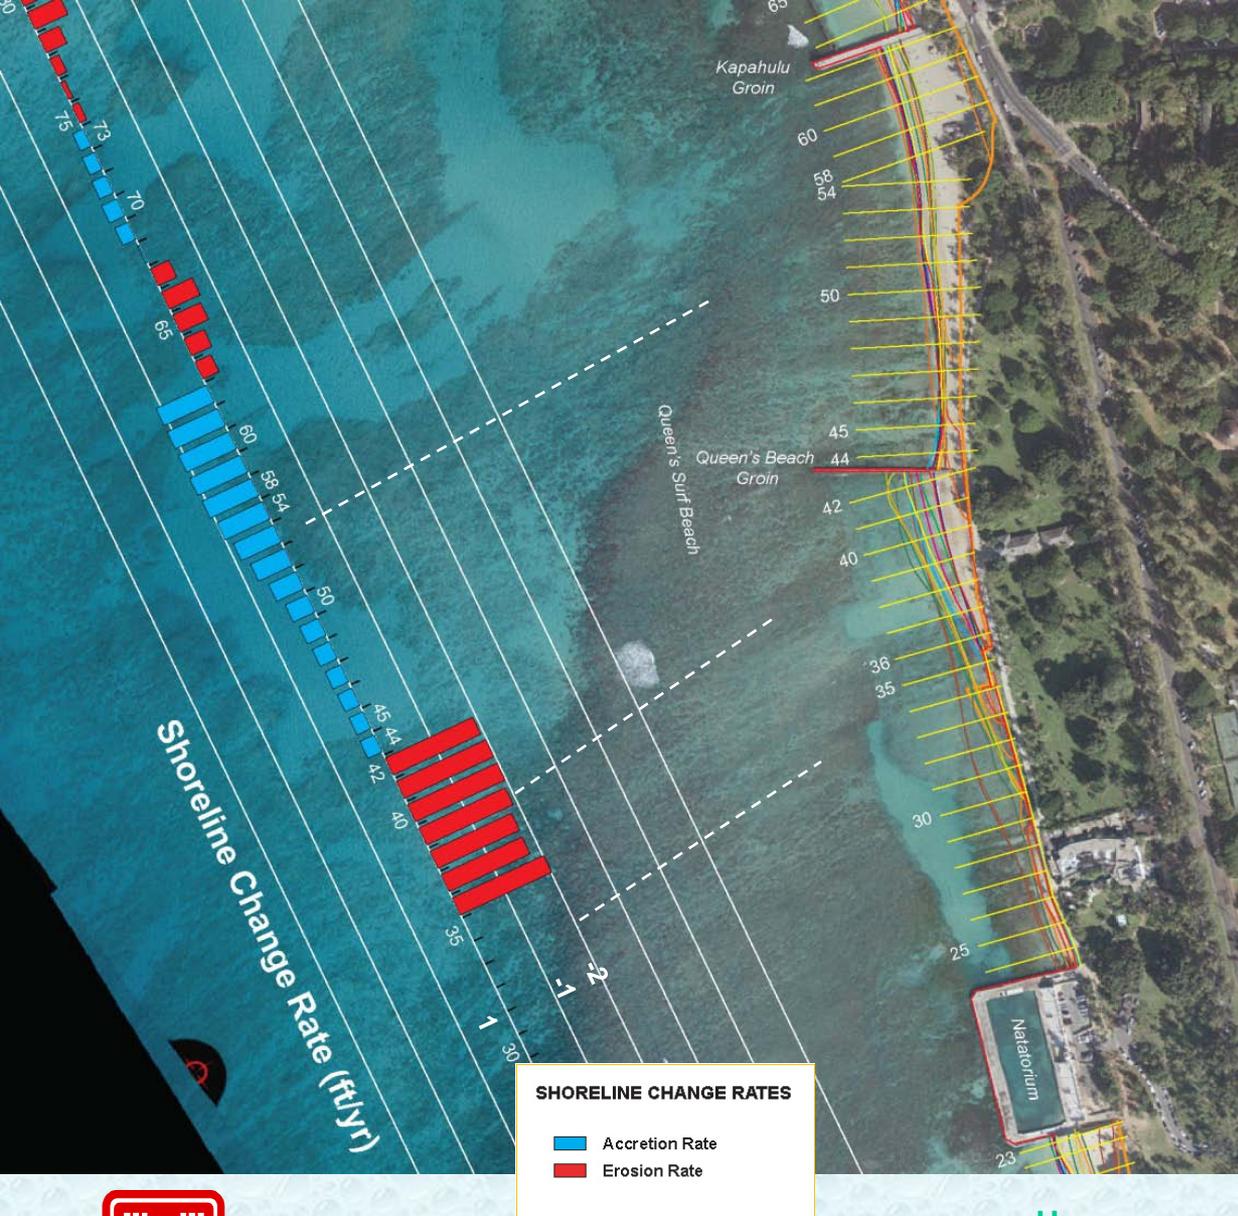
# Queen's - Kapahulu

1956 : Queen's beach built  
with sand fill, central groin

## Queen's 1957-2005

- Beach lost in south half  
1970's - 1980's
- Remainder eroding 2 ft/yr
- Natatorium blocks  
northerly sediment  
transport

## Kapahulu 1957-2005

- Accreting 0.5 to 1 ft/yr
- Sand fills post-1956?

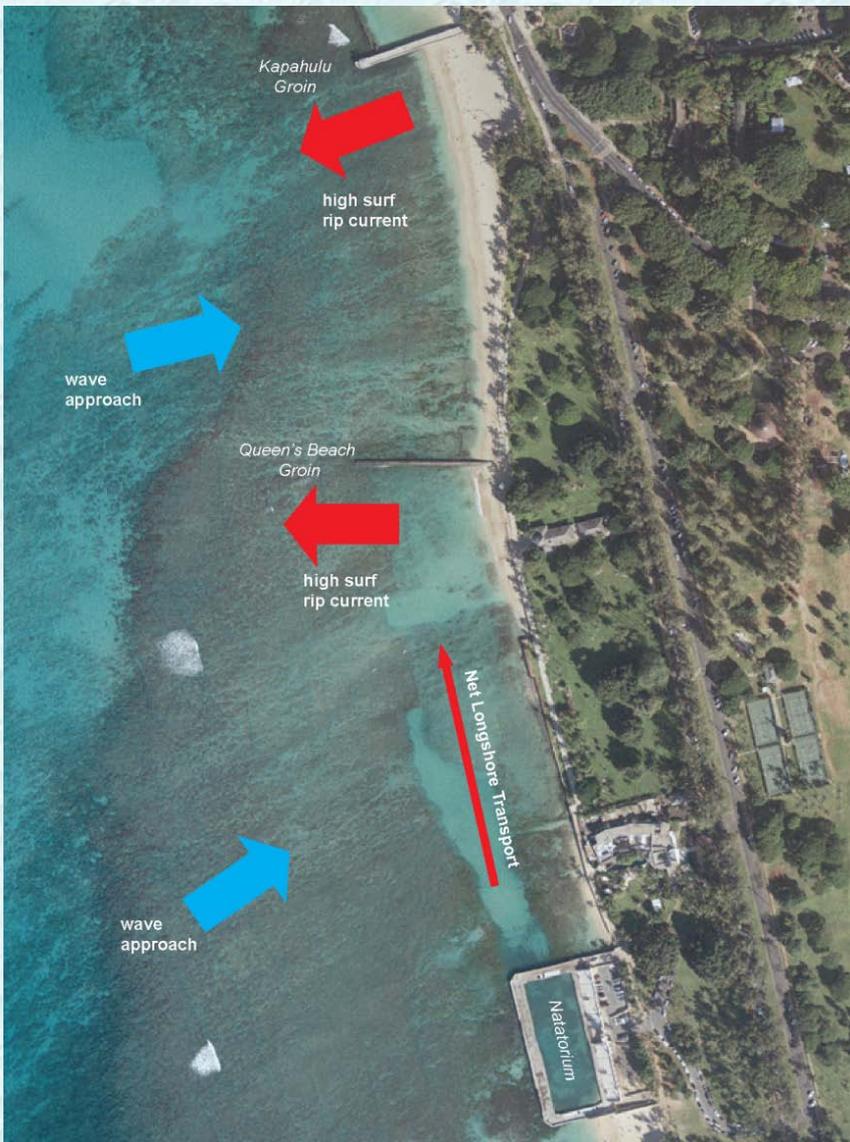
# Queen's - Kapahulu

Adapted from Miller and Fletcher, 2003

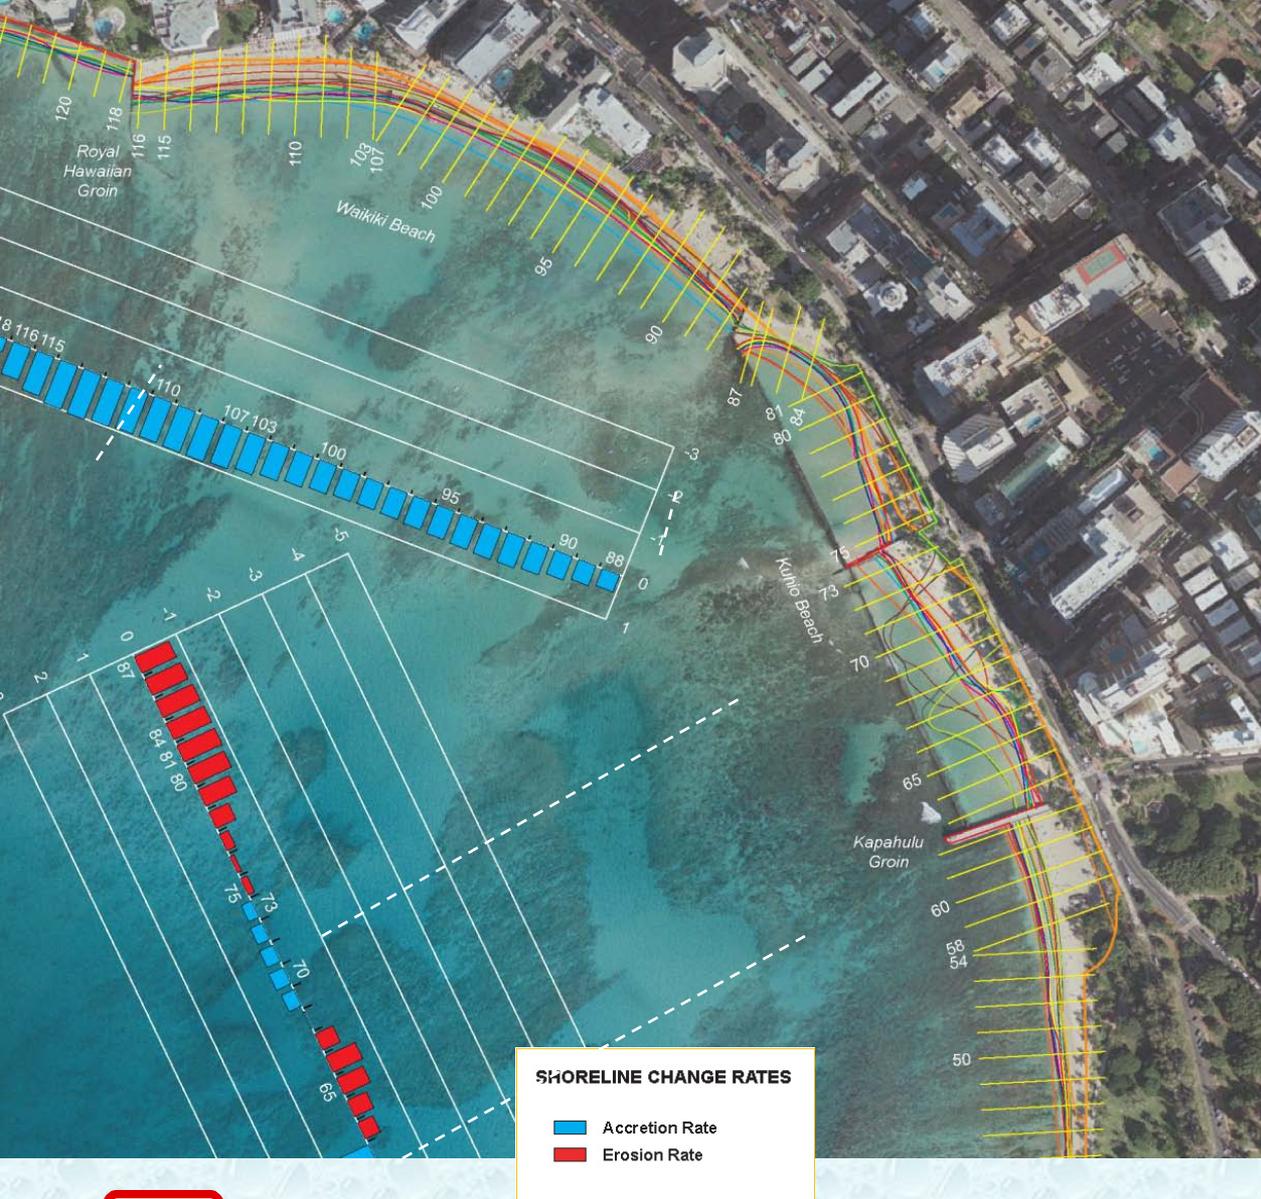
# Waikiki - Kuhio

## Kuhio Beach (1975-2005)

- 1972: Last major redesign
- Smaller fills: 1975, 1991, 2000, 2006
- Losing sand, despite crib walls and repeated fills.

## Waikiki (1927-2005)

- 1927: R.H. groin built
- Long-term (1927-2005): Accretion 0.5 to 1 ft/yr
- Short-term (1975-2005): Erosion ~ 1ft/yr 1975-2005 (not shown)

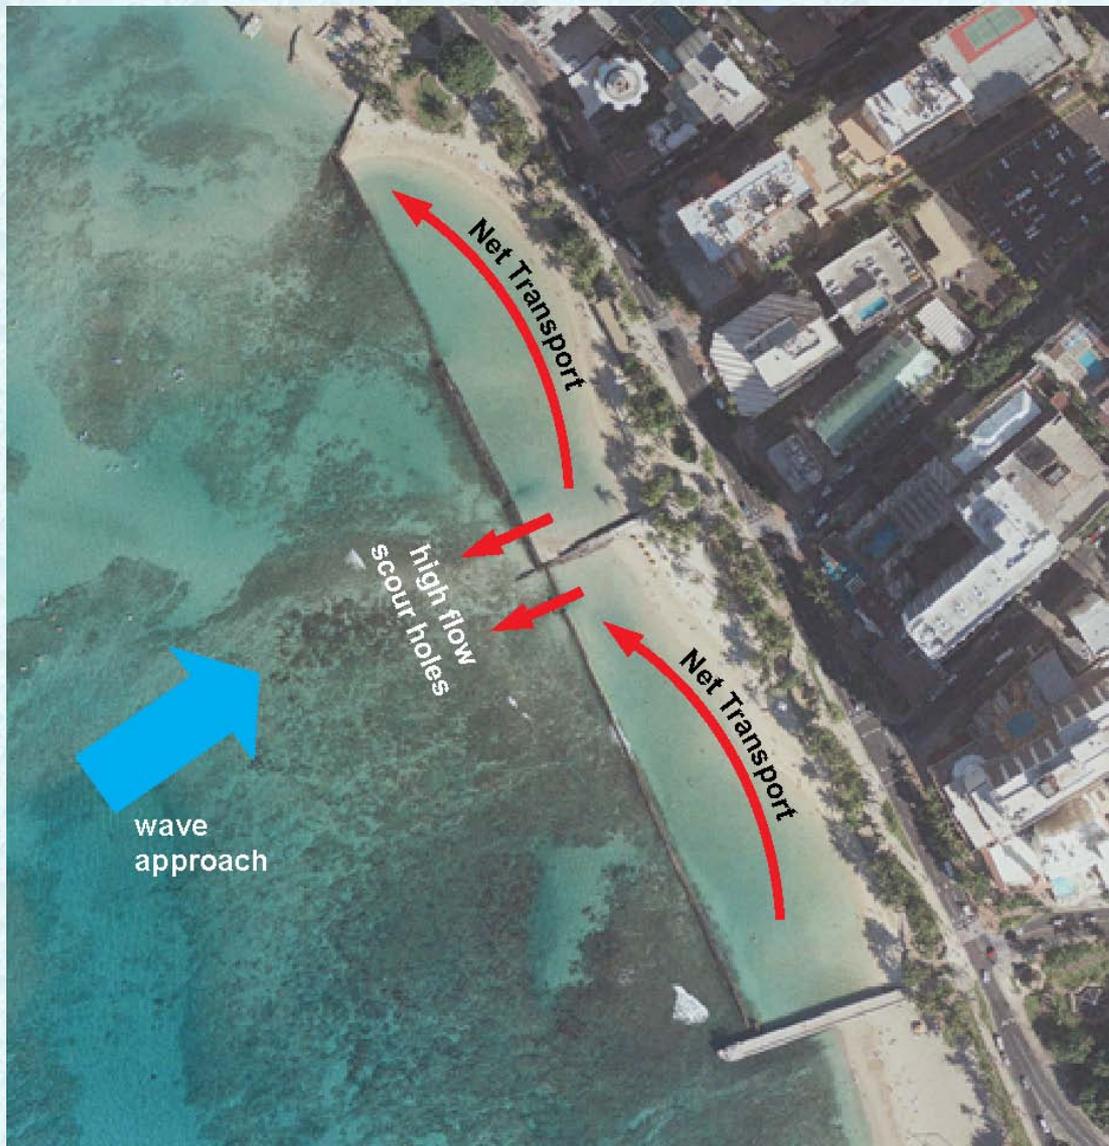
# Kuhio Beach

Adapted from Miller and Fletcher, 2003

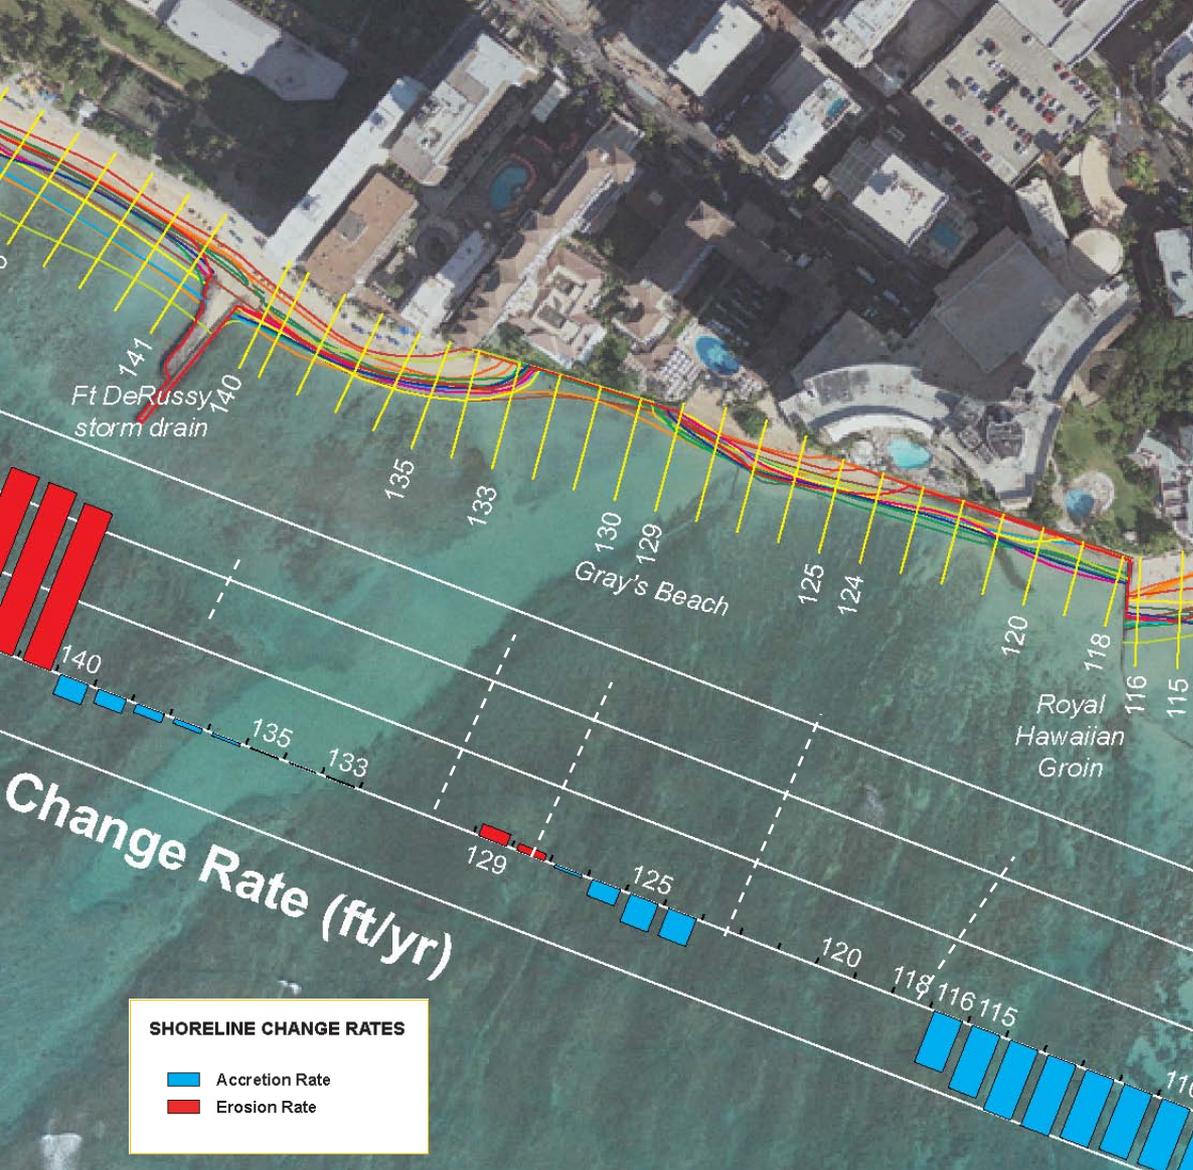
# Gray's / Halekulani

## Gray's / Halekulani (1927-2005)

- East end (Sheraton):  
Beach lost to erosion
- Central (fronting H.K.):  
No sig. beach in air photos,  
1927-2005
- Remaining beach is approx.  
stable to accreting

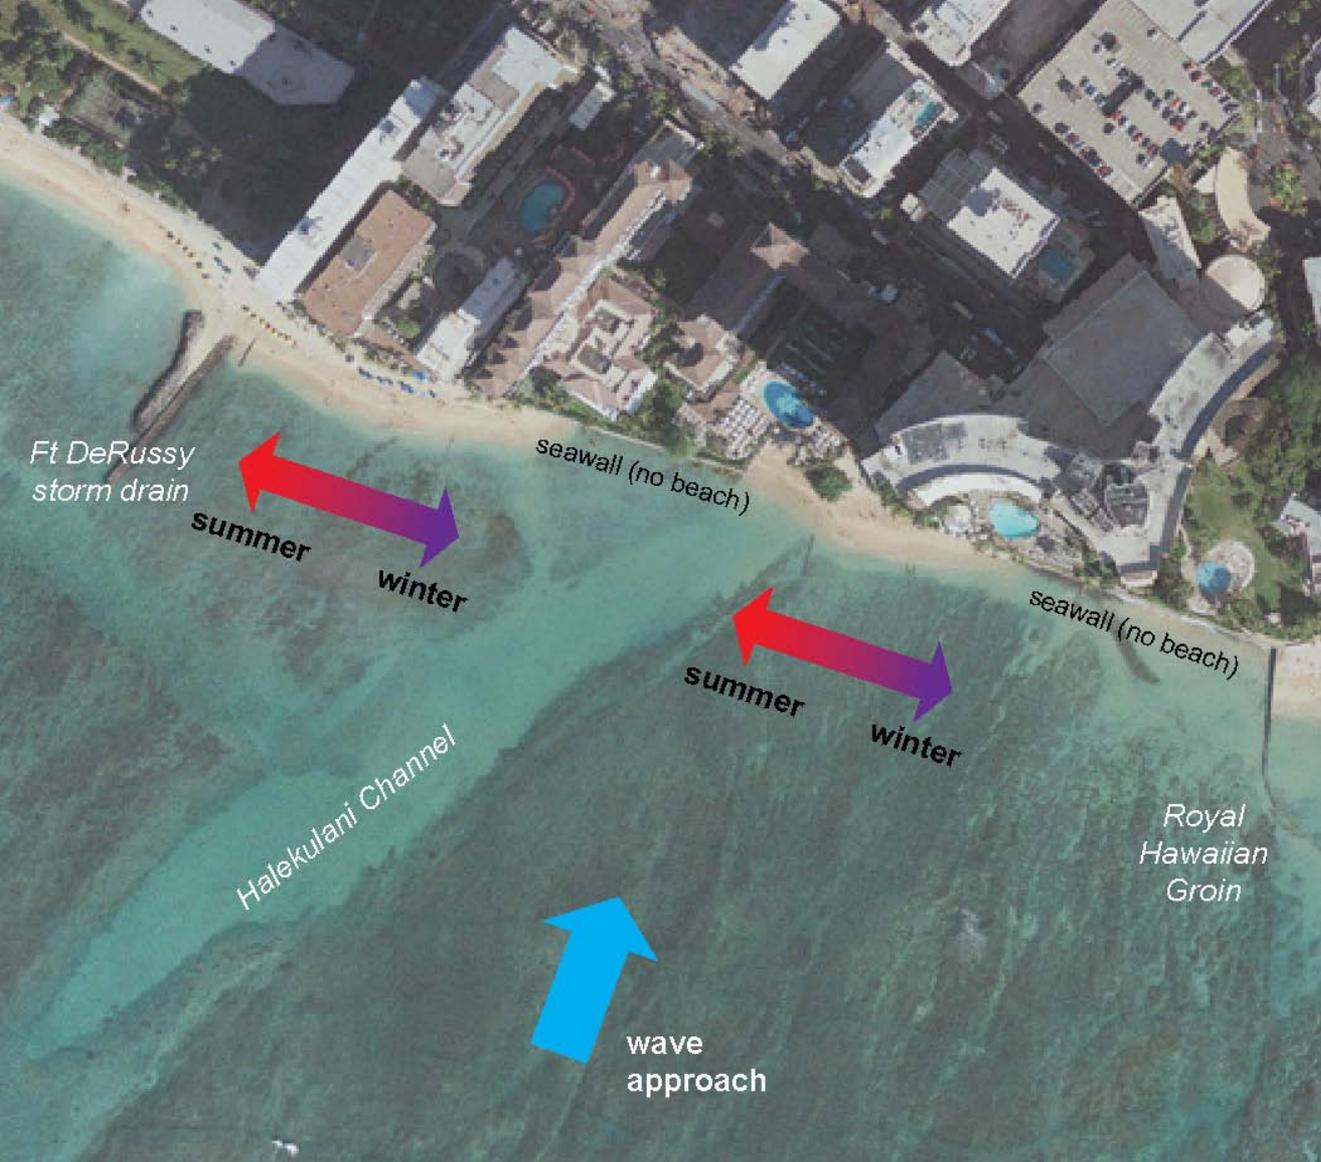
# Gray's / Halekulani

Adapted from Miller and Fletcher, 2003

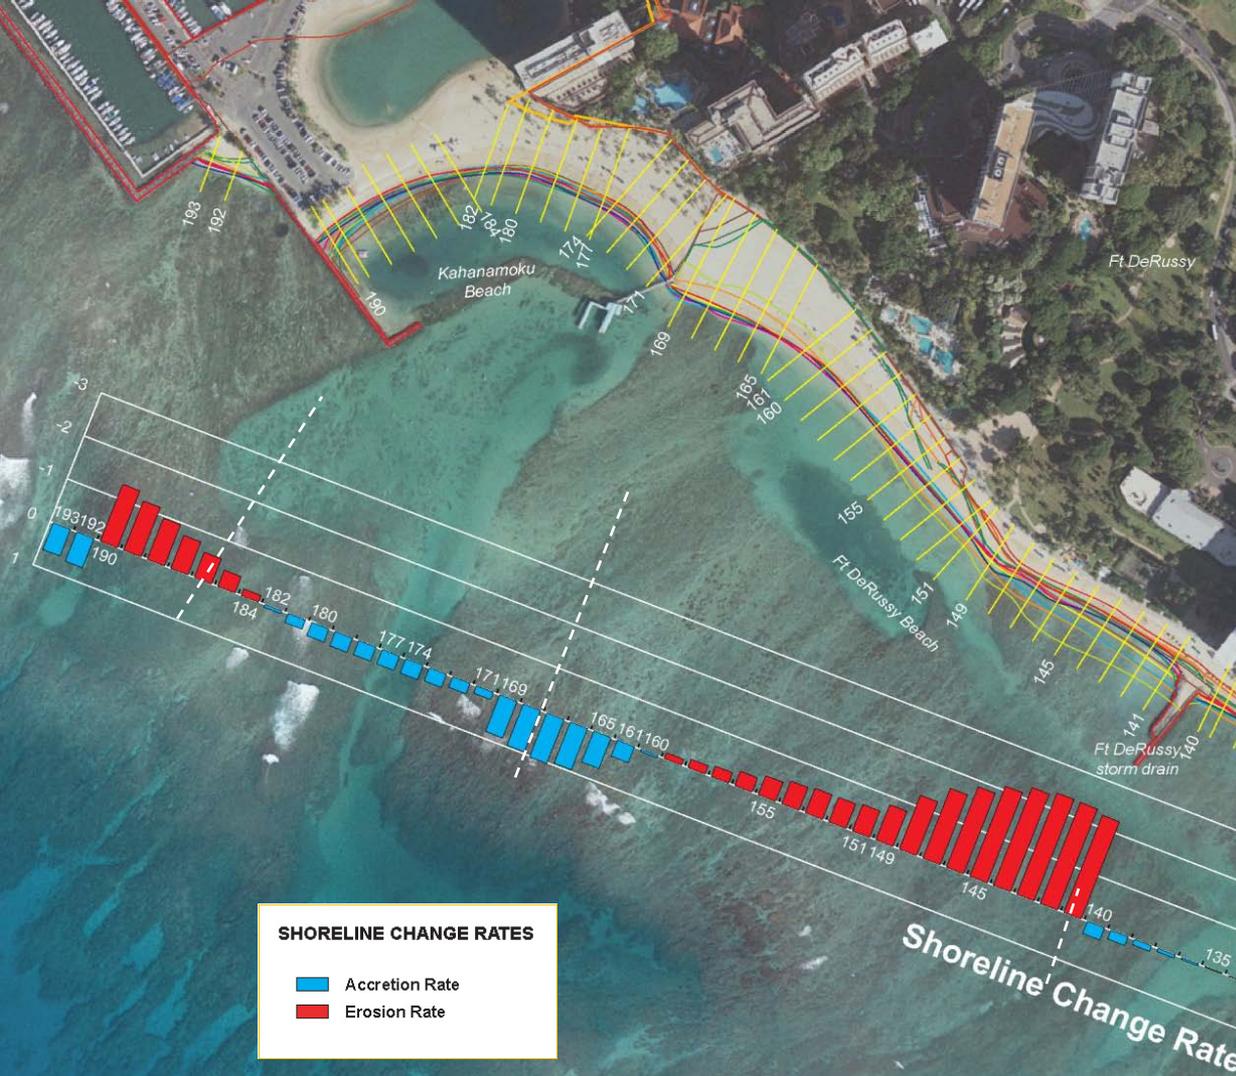
# Ft DeRussy– Kahanamoku

## Fort DeRussy (1975-2005)

- 1970: beach constructed
- Smaller fills: 1975, 1981
- North: Stable to accreting  
~1 ft/yr
- South: Erosion >2 ft/yr

## Kahanamoku (1957-2005)

- 1950's: beach constructed
- West : erosive, 0.5 to 1 ft/yr
- East : stable to accreting

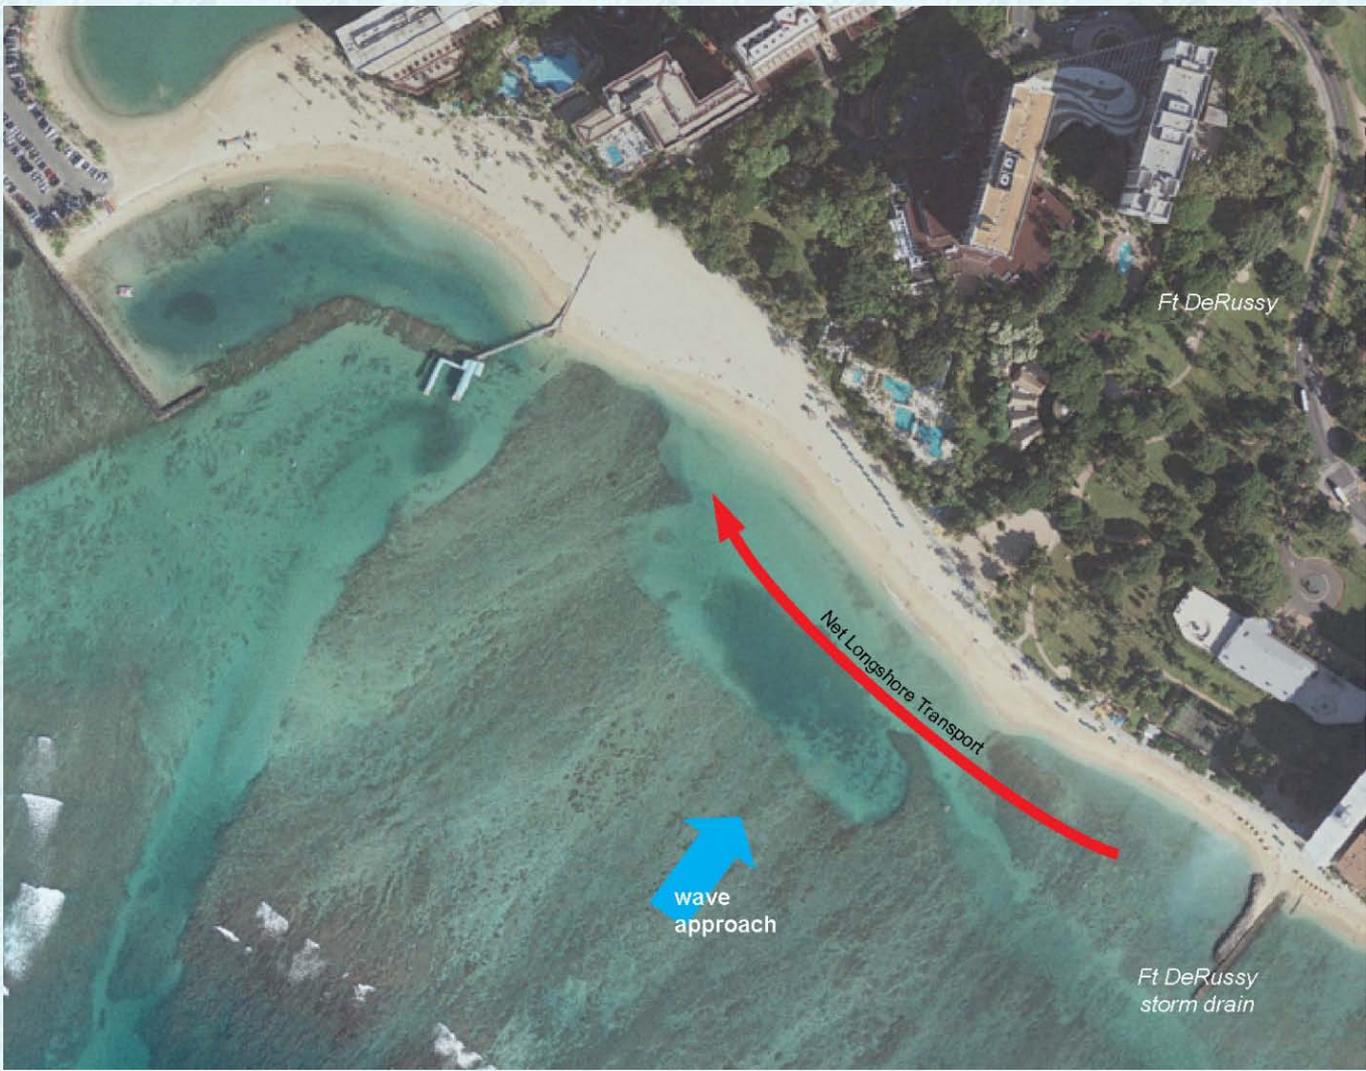
# Ft DeRussy– Kahanamoku

Adapted from Miller and Fletcher, 2003

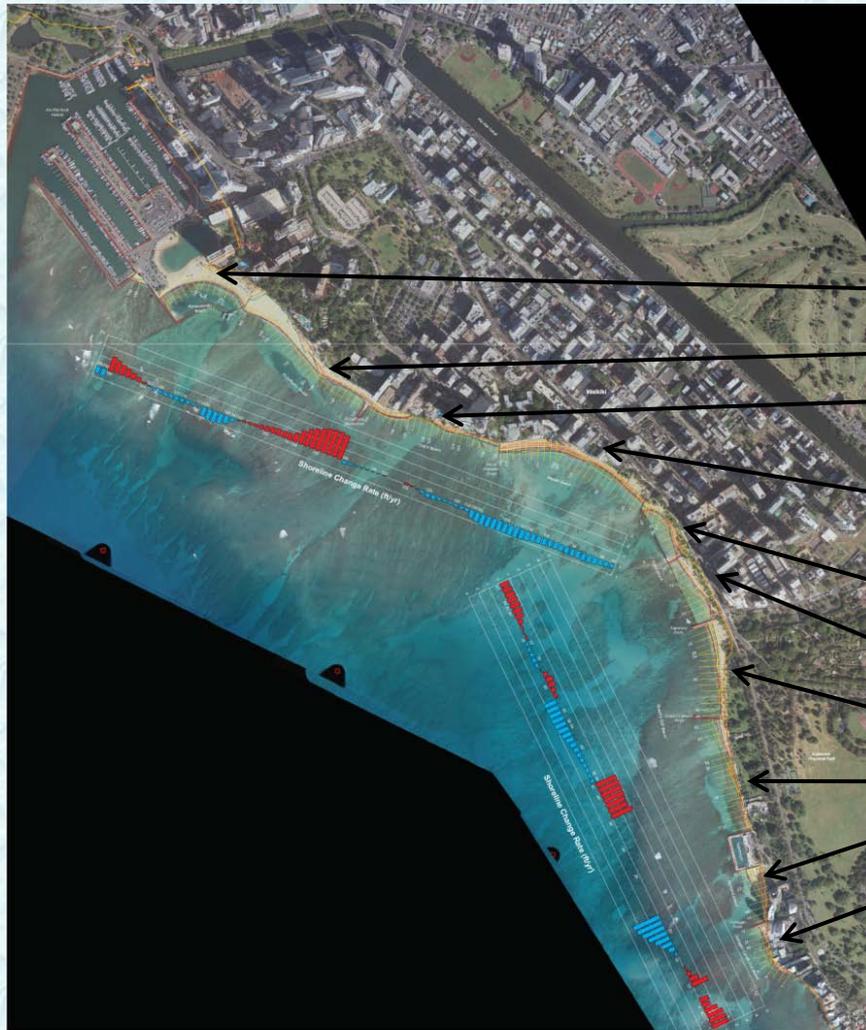
# Waikiki Summary

- Shoreline change analyzed at 172 transects, 3762 yd of beach
- Beach Lost: 25 transects, ~550 yd

## Average Rates

- Kahanamoku:  $-0.16 \pm 0.14$  ft/yr
- Ft DeRussy:  $-0.62 \pm 0.31$  ft/yr
- Gray's:  $0.12 \pm 0.15$  ft/yr
- Waikiki ('27-'05):  $0.74 \pm 0.16$  ft/yr
- Waikiki ('75-'05):  $-1.00 \pm 0.39$  ft/yr
- N. Kuhio:  $-0.61 \pm 0.36$  ft/yr
- S. Kuhio:  $-0.09 \pm 0.48$  ft/yr
- Kapahulu:  $0.70 \pm 0.12$  ft/yr
- Queen's:  $-1.85 \pm 0.37$  ft/yr
- Kaimana:  $1.51 \pm 0.19$  ft/yr
- Outrigger:  $-0.99 \pm 0.46$  ft/yr

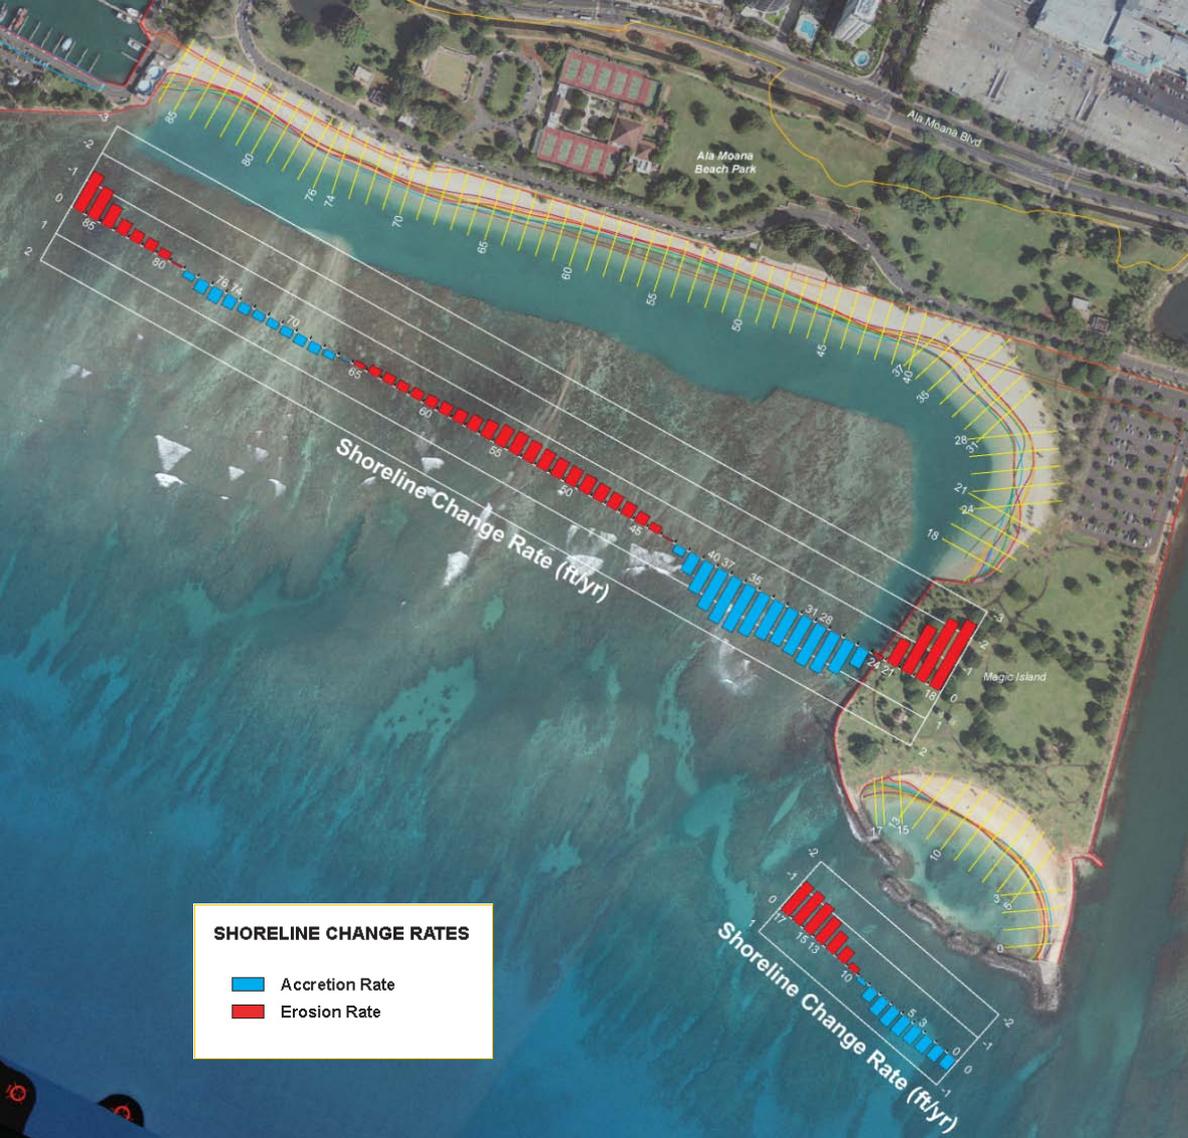
# Ala Moana – Magic Island

1950's – 1960's: Ala Moana and  
Magic Island Beaches  
constructed with dredge fill  
1976: Ala Moana BP fill 30k yd<sup>3</sup>

## Magic Island (1968-2005)

- Erosion west
- Accretion east
- Avg. rate:  $-0.09 \pm 0.18$  ft/yr

## Ala Moana BP (1968-2005)

- Alternating cells of erosion and accretion
- Avg. rate:  $-0.04 \pm 0.14$  ft/yr

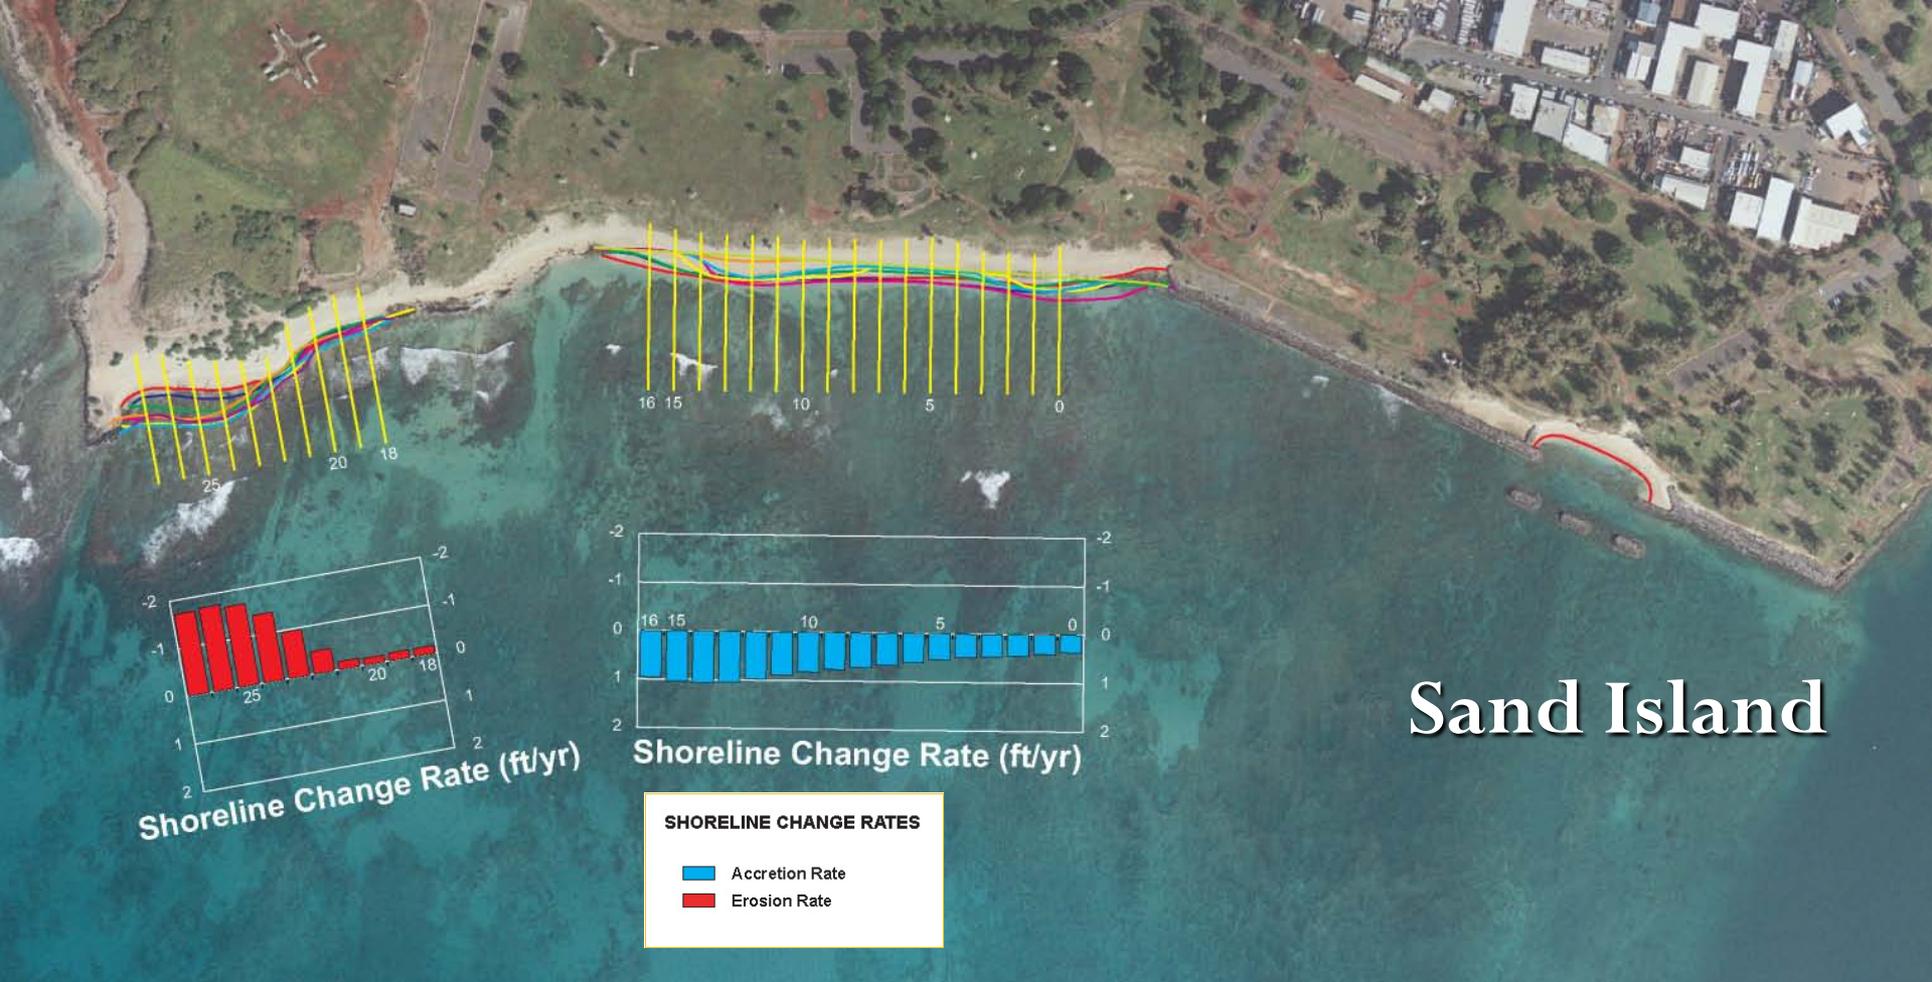
# Sand Island

- 1940's: Sand Island, beaches constructed with dredge fill
- 1949-2005: Central beach accreting up to 1 ft/yr; East eroding >1ft/yr
