# South Oahu Shoreline Change: Diamond Head – Pearl Harbor

Chip Fletcher and Brad Romine  
University of Hawaii  
Coastal Geology Group

# South Oahu Shoreline Change

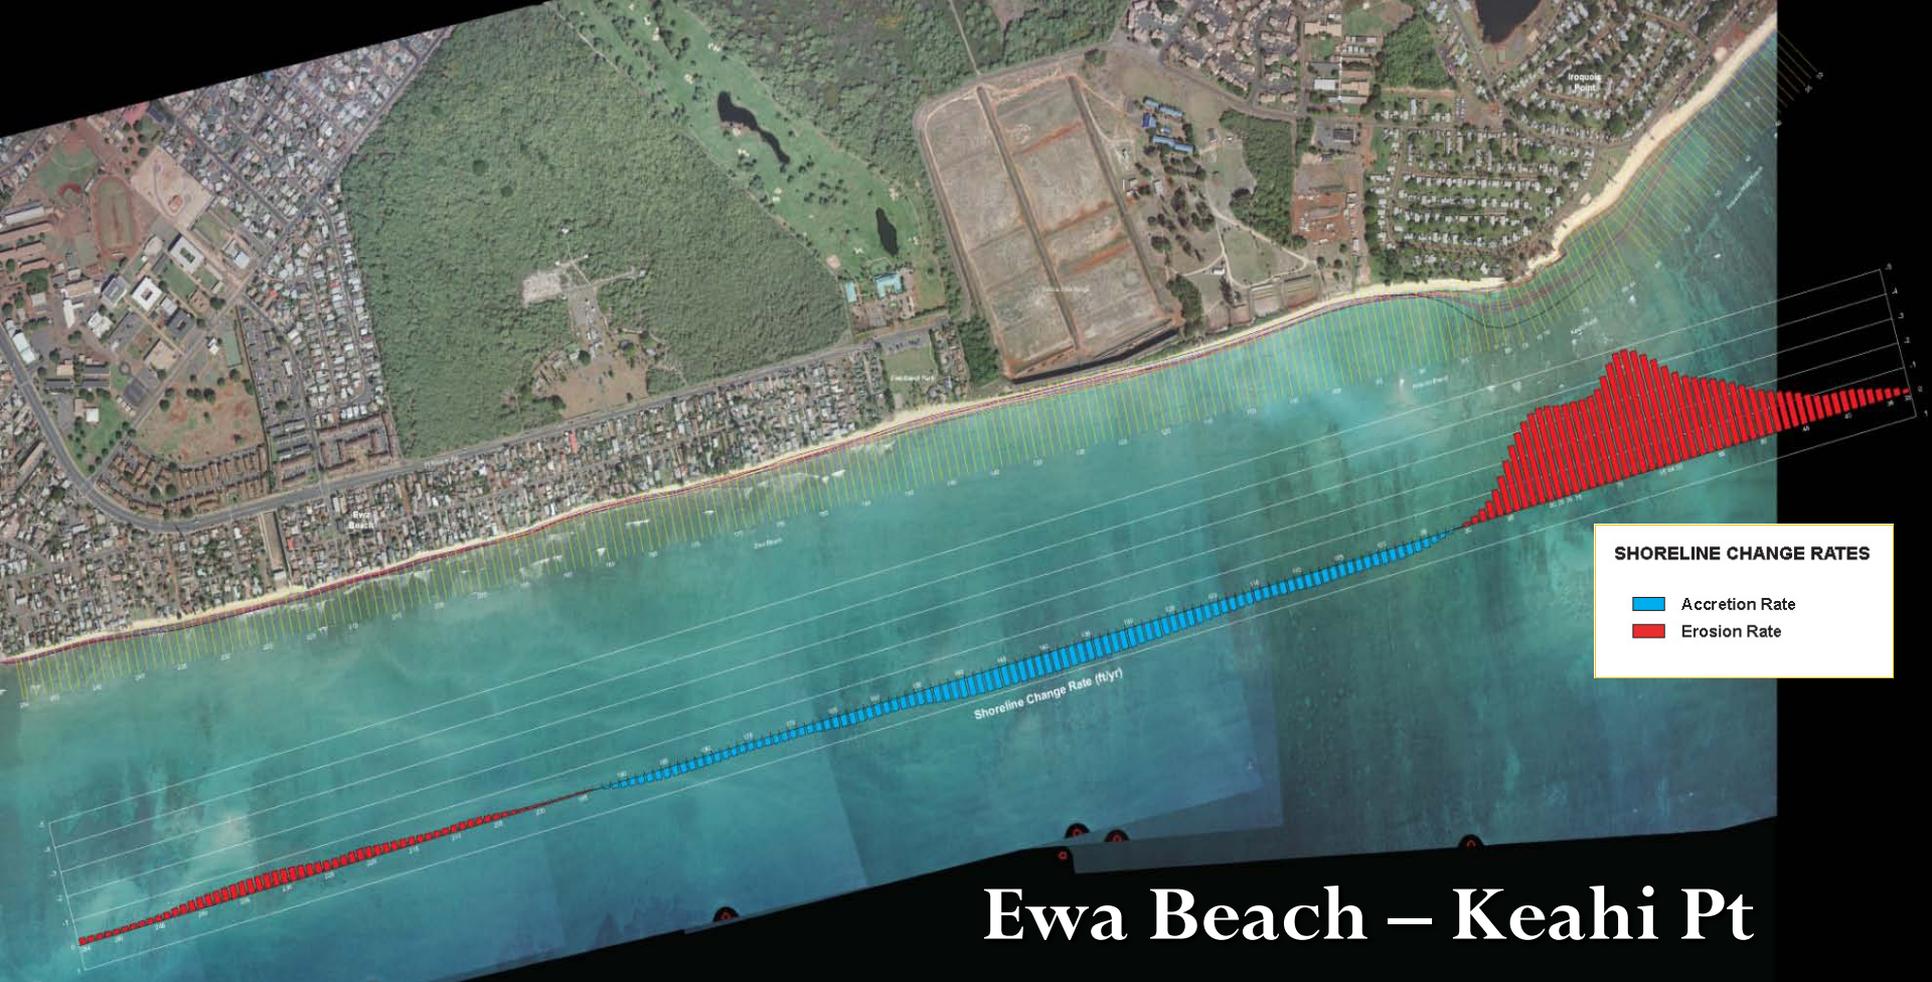
# Ewa Beach – Keahi Pt

- Keahi – Iroquois Pt: Erosion up to 5 ft/yr (1928, 1950 -2005)
- Central Ewa Beach: Accreting (<1ft/yr) to approx. stable (1928-2005)
- West Ewa Beach: Eroding (<1 ft/yr) to approx. stable (1928-2005)

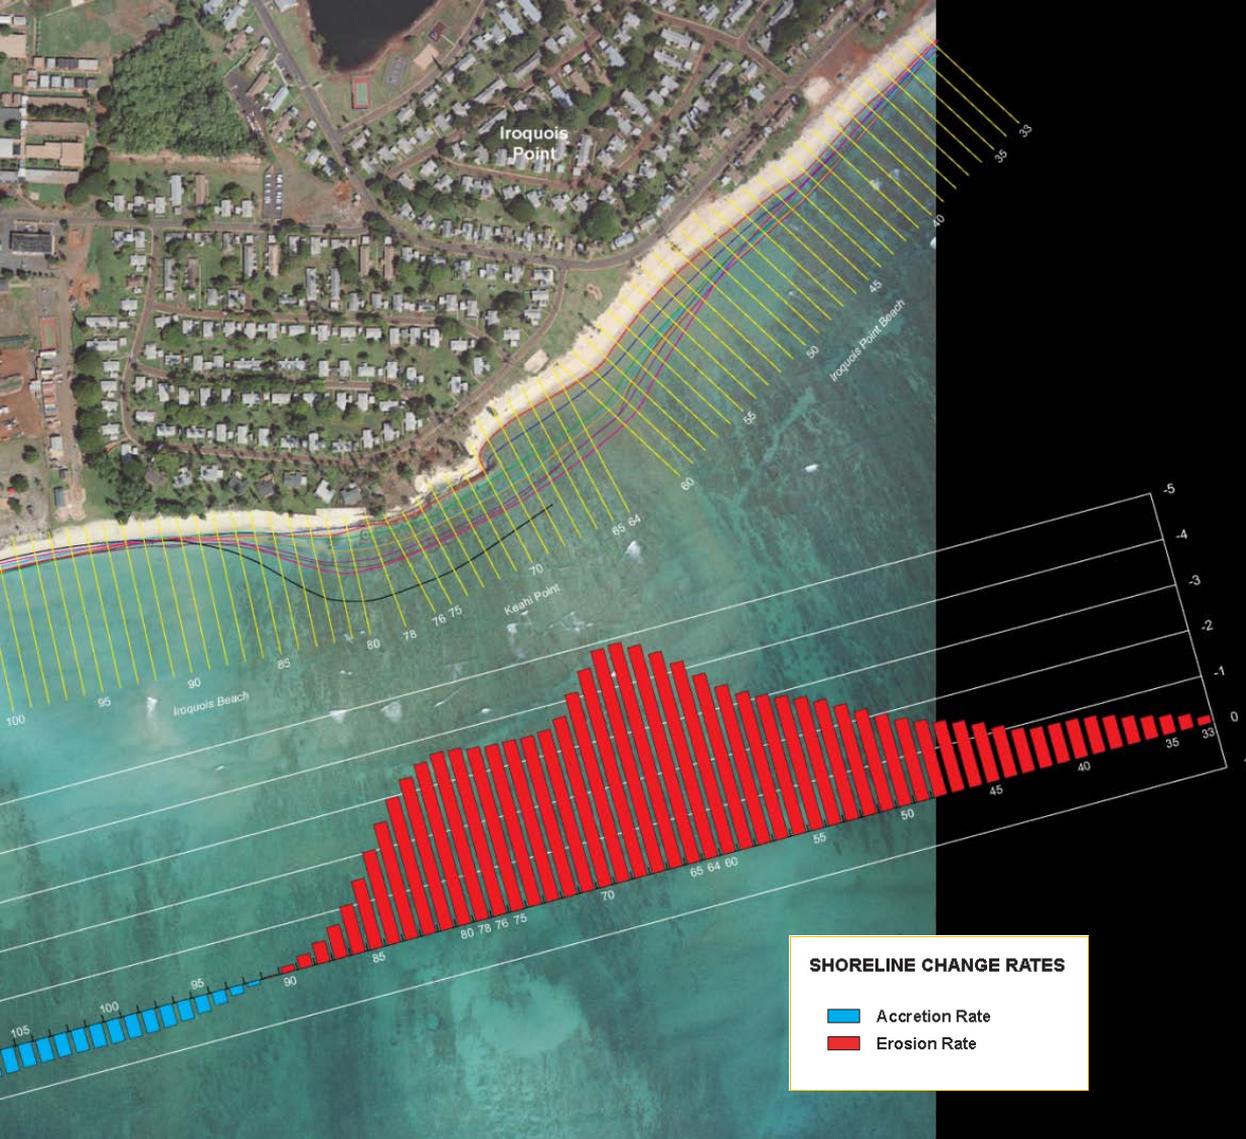
# Keahi– Iroquois Pt

## Keahi Point (1928, 1950 -2005)

- Erosion up to 5 ft/yr
- 1976 to 1988 Beachfront homes removed and bolder revetments installed
- Erosion continues between and around revetments
